# **Preventive measures against water leakage in Tokyo**

## **Reducing number of water leakage repairs by 90% by the efforts of material quality improvement of service pipes**

**T. Okabe\*, A. Tomaru\*\***

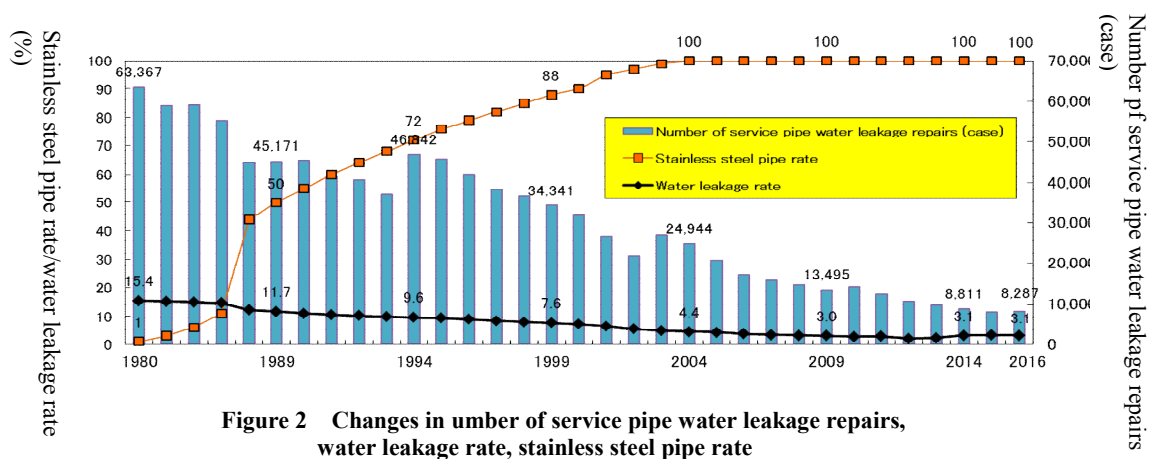
These initiatives ultimately reduced the number of water leakage repairs per year in Tokyo by roughly 88% (67,361 cases to 8,287 cases) relative to 1979, the period before stainless steel pipes were introduced (Figure 2).

Figure 2 Changes in number of service pipe water leakage repairs, water leakage rate, stainless steel pipe rate

Initially, stainless steel pipes were used only for new service pipes, when changing pipe diameters, or when performing other modification work. However, to reduce the frequency of water leakage in service pipes, which accounted for most such leaks, work began in 1982 to systematically replace all service pipes with stainless steel pipes to coincide with replacements of distribution pipes, leak repairs, and other initiatives. By 2006, after around 25 years of work, we had successfully replaced all service pipes located under roads with stainless steel pipes.
